To the Question of the Mechanism of the Effect of Coating on the Durability of Tools from PCBN

TO THE QUESTION OF THE MECHANISM OF THE EFFECT OF COATING ON THE DURABILITY OF TOOLS FROM PCBN

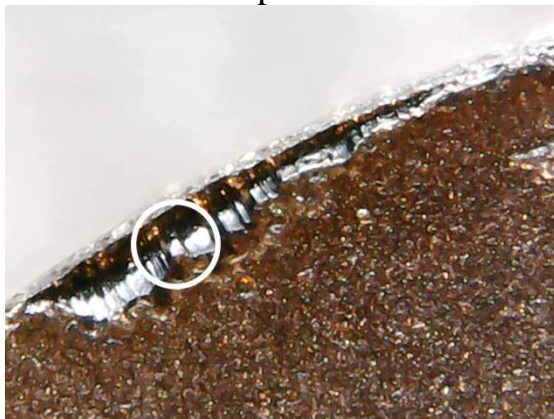
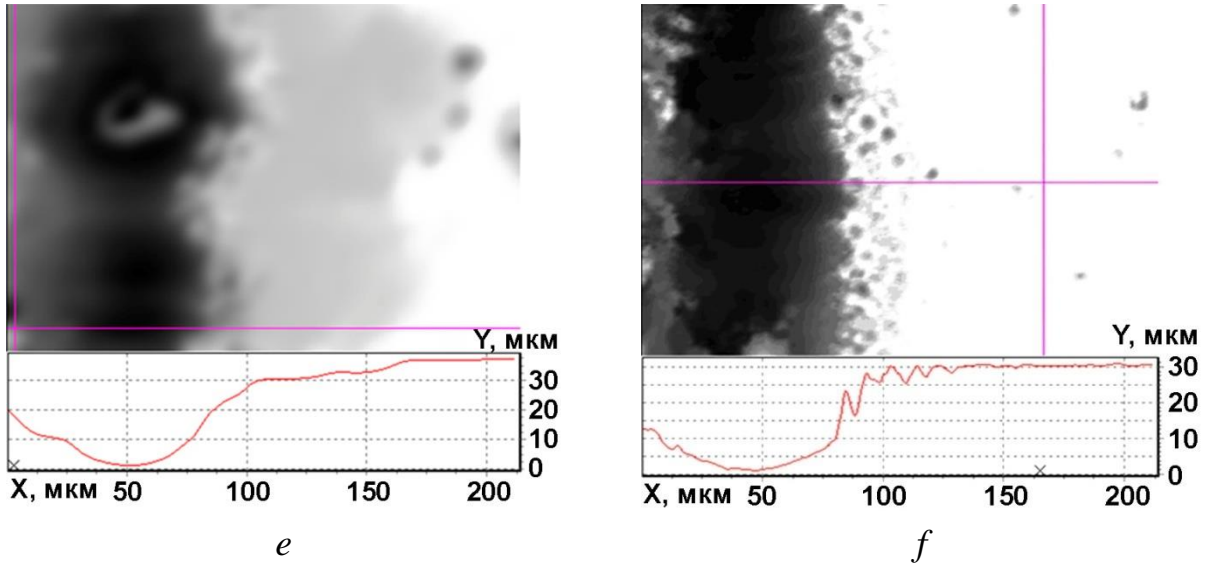
To answer the question about the causes of a decrease in the intensity of tool wear in the presence of a coating, let us consider the state of the contact surfaces of the tool after machining. In fig. 3 the holls on the front surface of the tool are shown. Although visually noticeable changes in their shape in length, no significant quantitative differences have been identified. The width of the crater after 20 minutes of cutting is ~ 100 microns, depth close to 30 microns. Additional tests in which tools were used, on which the coating from the front surface was ground, showed only a slight increase in the intensity of their wear (Fig. 1).

Figure 3. Topography of the front surface of coated tools (*a, c, e*) and without (*b, e, f*). 3-D image of the hole on the front surface of the tool (*c, d*), the profile of the hole in the radial section (*e, f*)

The absence of significant differences in the shape of the crater on the rake surface allows us to conclude that the coating on such a surface has little effect on the contact phenomena in the area where the tool interacts with the chips.

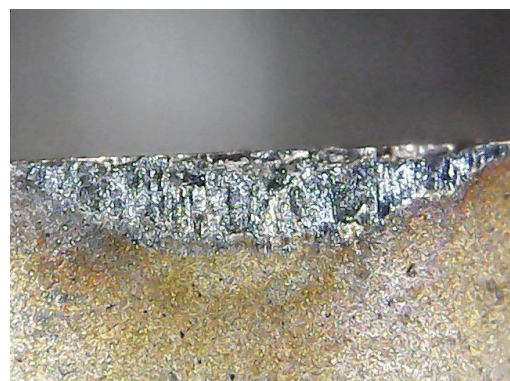
The key to understanding the reasons for the increase in tool life can be an analysis of wear chamfer images on the back surface (Fig. 5). The analysis shows the presence of adhered layer on the contact areas. According to X-ray microanalysis of worn-out contact areas, the iron content in the secondary phase on a coated tool is significantly higher – from 38 to 84%, while on a tool without a secondary phase coating that includes iron is significantly less – up to 30%. It can be assumed that the layer of the secondary phase on the contact surface is directly related to the wear rate of the tool.

Figure 5. Morphology of worn areas of the back surface of the tool (*a, c, e, g*) – without coating; (*b, d, f, h* – with coating)

Under the conditions considered, when turning hardened steel on the worn surface of the tool from the flank surface, a secondary phase is observed. At the same time, the amount of adhered material is significantly higher than on an uncoated tool.

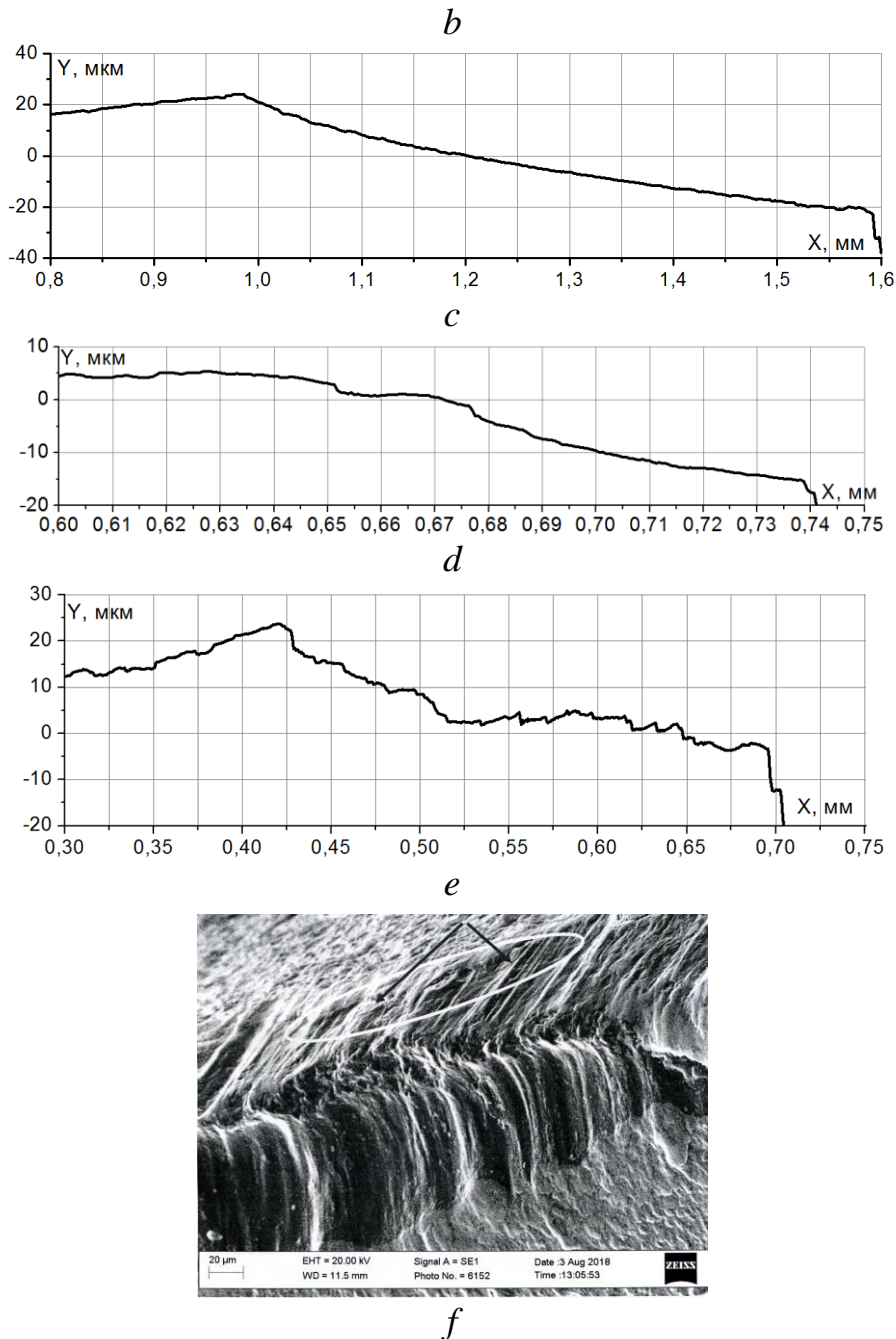
Let us estimate the stress-strain state of the material being processed in this zone for both types of tools. To do this, we use the topography parameters of the worn contact area of the tool from the back surface, estimated according to the scheme shown in Fig. 6, *a*.

In fig. 6, *b-e* the flank wear profiles of the tool with (TiAlSiY)N/CrN and without coating, formed during the turning of the HVG steel are shown. Worn sections of the coated tool are characterized by a developed profile shape in cross section, which is partly explained by the presence of a secondary phase on the surfaces and irregularities in the transition zone from the worn area to the free (side) surface of the cutting tool, which was also observed in electron microscopic studies (Fig. 6, *f*).

Figure 6. Section of the cutting plate in which profilometry was carried out (*a*), profile of the chamfer wear on the flank surface: *b* – tool without coating, cutting time 20 minutes; *c* – uncoated tool, cutting time 40 minutes; *d* – coated tool, cutting time 20 minutes; *e* – coated tool, cutting time 40 minutes; *f* – micro irregularities on the periphery of contact area.

Worn areas on the back surface of the coated tool are characterized by a developed profile shape in cross section, which is partly explained by the presence of a secondary phase and unevenness in the transition zone from the worn area to the free (side) surface of the tool.
